**Flood Control Project Maintenance
Levee Inspections**
LMA District Cover Sheet
Spring 2018 Levee Inspection Results

Reclamation District No. 0817 Carlin

Spring 2018 Levee Inspection Results

Waterway			Bank	Unit Miles
Unit No. 01 South Dry Creek			Left	3.81
	Spring (March - May)	Summer (June - August)	(September - November) Fall	Winter (December - February)
Unit Maintenance Rating (Fall Only)				
Date of Inspection	4/18/2018 - 4/18/2018			
DWR Inspector	Sterling York			
Accompanied By	Joe Conant RD 817			
	Tom Engler RD 2103

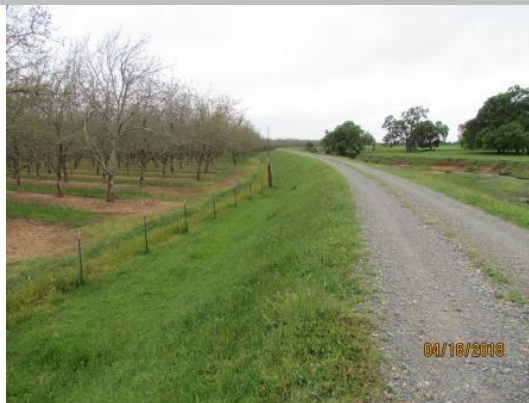
Photo 1 of 1 : SP_2018_RD0817_12_26_20180501_00018.jpg

View looking downstream landside of the maintained annual vegetation, Spring 2018.

LM Start	0.00	Rating **	A	Issue No.	27
LM End	3.81	Issue Type +	Ma	Location *	WS
Category	Earthen Levee			GPS Latitude/Longitude	
				Start	End
Item	Vegetation			38.984668 °	39.019765 °
				-121.506110 °	-121.454085 °
DWR ID	DWR_RD0817_01_s_2018_27				
Comment Code					
V1 : Control annual grass and weeds on the levee slopes and easements.					
Inspector Comment					
Annual vegetation is maintained, Spring 2018.

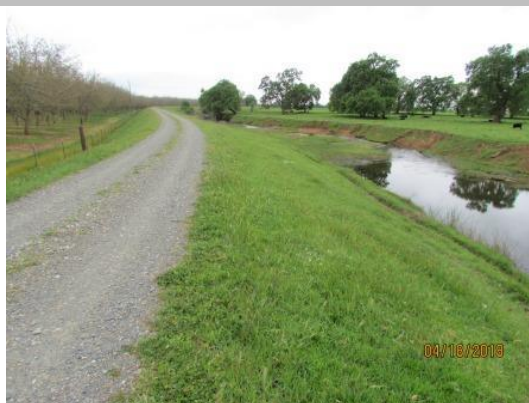
Photo 1 of 1 : SP_2018_RD0817_12_27_20180501_00019.jpg

View looking downstream waterside of the maintained annual vegetation, Spring 2018.

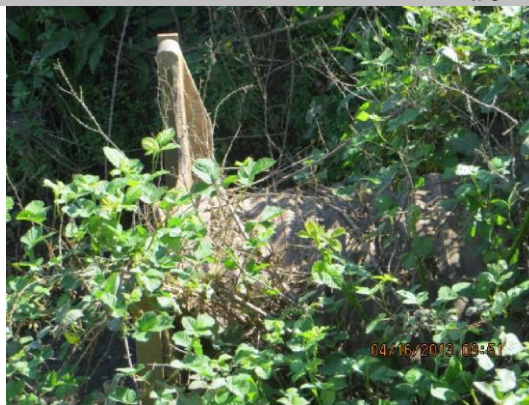
Photo 2 of 3 : UCIP_SP_2018_42685_19864.jpg

WS- CM pipe and flap gate

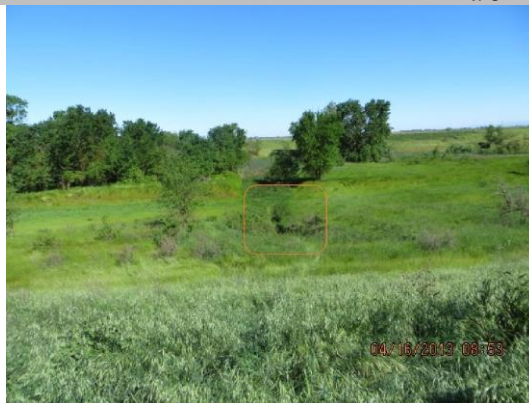
Photo 3 of 3 : UCIP_SP_2018_42685_19863.jpg

LM Start	0.29	Rating **	M	Issue No.	28 (cont)	
LM End	0.29	Issue Type +	Ma	Location *		
Category	Supplemental			GPS Latitude/Longitude		
				Start	End	
Item	DWR UCIP LMA Responsibility			38.987813 °	38.987813 °	
				-121.502963 °	-121.502963 °	
DWR ID						
Comment Code						
Inspector Comment						
FS_ID:42685 DS_ID:18985 EP_NO: N/A Repair Type: Non-Urgent Crossing Status: Found UCIP Comments: Dense vegetation on waterward and landward slopes limit visual inspection of potential leaks along pipe alignment. Recommend having owner clear vegetation along slopes. FIELD_STRUCT_DESC: 48-inch corrugated metal gravity drainage pipe through the levee, 23.3 feet below the crown. Flap gate on the waterside (WS) end. [Additional Reference(s): DWR Levee Log, 2005. USACE Sacramento O&M Manual 146, November 1962, (HLM 0.28)]. FS Date: 4/16/2013

WS- dense vegetation on WS of the levee

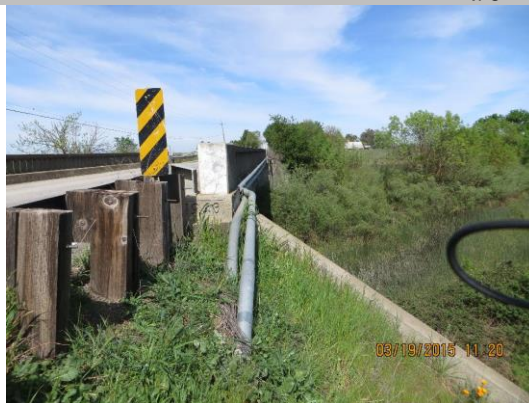
Photo 1 of 2 : UCIP_SP_2018_44084_73565.jpg

LM Start	1.13	Rating **	M	Issue No.	34	
LM End	1.13	Issue Type +	En	Location *		
Category	Supplemental			GPS Latitude/Longitude		
				Start	End	
Item	DWR UCIP Field Study			38.995667 °	38.995667 °	
				-121.490981 °	-121.490981 °	
DWR ID						
Comment Code						
Inspector Comment						
FS_ID:44084 DS_ID:25088 EP_NO: N/A Repair Type: Non-Urgent Crossing Status: Found UCIP Comments: No permit identified for this crossing. FIELD_STRUCT_DESC: *DUPLICATE--DELETE ENTRY* 4-inch steel telephone conduit through the levee, 4 feet below the crown. FS Date: 3/19/2015

Communication conduit visible on upstream side of bridge.

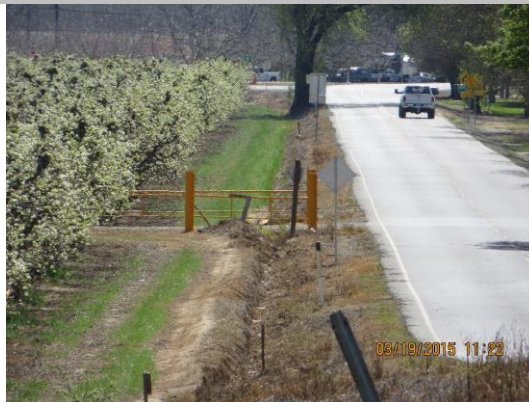
Photo 2 of 2 : UCIP_SP_2018_44084_73564.jpg

Fiberoptic line markers along roadway to south of bridge.

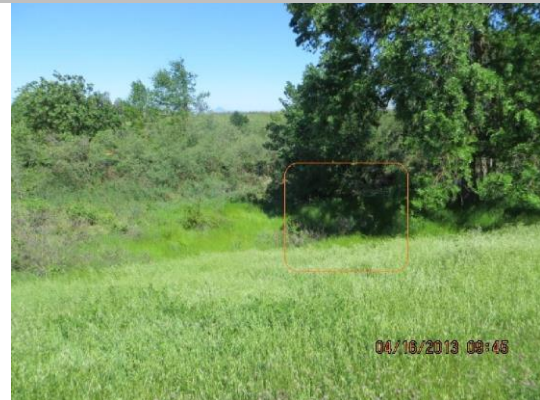
Photo 1 of 3 : UCIP_SP_2018_41153_19882.jpg

Comment Code					
Inspector Comment					
FS_ID:41153 DS_ID:18987 EP_NO: N/A Repair Type: Non-Urgent Crossing Status: Found UCIP Comments: Damaged slide gate on WS of the levee. Need to contact owner to determine status of crossing. If crossing is no longer in use owner will need to contact CVFPB to comply with Title 23. Dense vegetation on waterward and landward slopes limit visual inspection of potential leaks along pipe alignment. Recommend having owner clear vegetation along slopes. FIELD_STRUCT_DESC: *ABANDONED* 18-inch corrugated metal gravity drainage pipe through the levee, 14.9 feet below the crown. Slide gate on the waterside (WS) end. [Additional Reference(s): DWR Levee Log, 2005. USACE Sacramento O&M Manual 146, November 1962, (HLM 1.34)]. FS Date: 4/16/2013

WS- overview of WS area

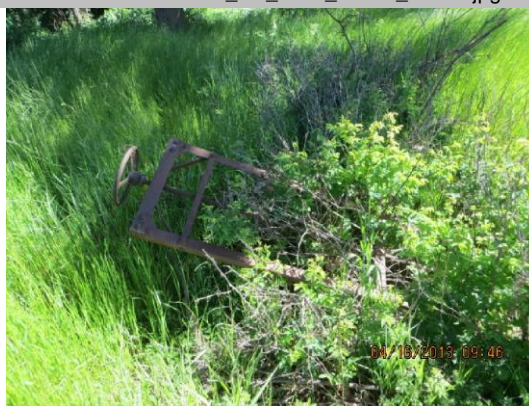
Photo 2 of 3 : UCIP_SP_2018_41153_19881.jpg

Comment Code						
Inspector Comment						
FS_ID:41153						
DS_ID:18987						
EP_NO: N/A						
Repair Type: Non-Urgent						
Crossing Status: Found						
UCIP Comments: Damaged slide gate on WS of the levee. Need to contact owner to determine status of crossing. If crossing is no longer in use owner will need to contact CVFPB to comply with Title 23. Dense vegetation on waterward and landward slopes limit visual inspection of potential leaks along pipe alignment. Recommend having owner clear vegetation along slopes.						
FIELD_STRUCT_DESC: *ABANDONED* 18-inch corrugated metal gravity drainage pipe through the levee, 14.9 feet below the crown. Slide gate on the waterside (WS) end. [Additional Reference(s): DWR Levee Log, 2005. USACE Sacramento O&M Manual 146, November 1962, (HLM 1.34)].						
FS Date: 4/16/2013

WS- closer look at damaged slide gate on WS

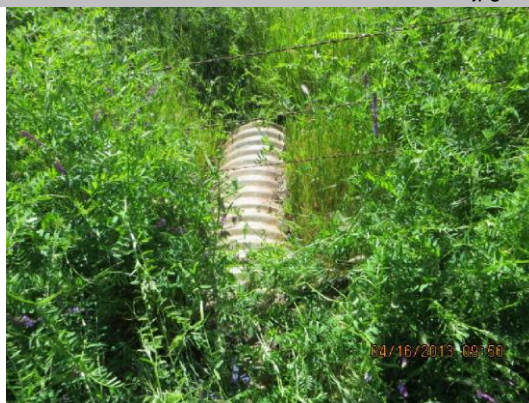
Photo 3 of 3 : UCIP_SP_2018_41153_19884.jpg

LS- CMP on toe of the levee.

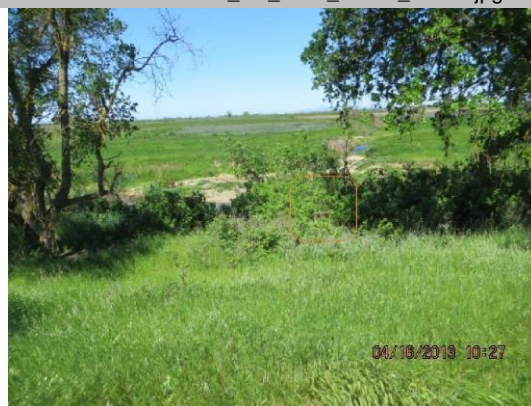
Photo 1 of 3 : UCIP_SP_2018_41157_19892.jpg

Comment Code						
Inspector Comment						
FS_ID:41157						
DS_ID:18988						
EP_NO: N/A						
Repair Type: Non-Urgent						
Crossing Status: Found						
UCIP Comments: A burried slide gate on WS of the levee. Need to contact owner to determine status of crossing. If crossing is no longer in use owner will need to contact CVFPB to comply with Title 23. Dense vegetation on waterward and landward slopes limit visual inspection of potential leaks along pipe alignment. Recommend having owner clear vegetation along slopes.						
FIELD_STRUCT_DESC: *ABANDONED* 18-inch corrugated metal gravity drainage pipe through the levee, 13.8 feet below the crown. Slide gate on the waterside (WS) end. [Additional Reference(s): DWR Levee Log, 2005. USACE Sacramento O&M Manual 146, November 1962, (HLM 1.62)].						
FS Date: 4/16/2013

WS- overview of WS berm

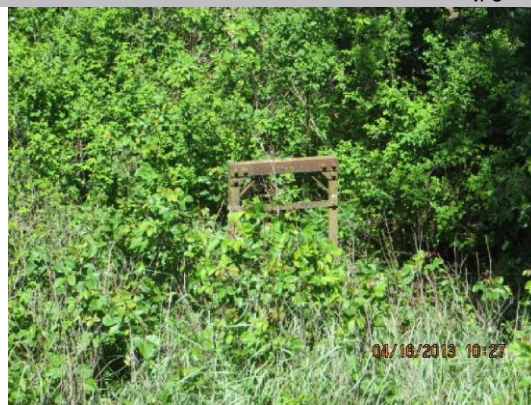
Photo 2 of 3 : UCIP_SP_2018_41157_19891.jpg

WS- slide gate

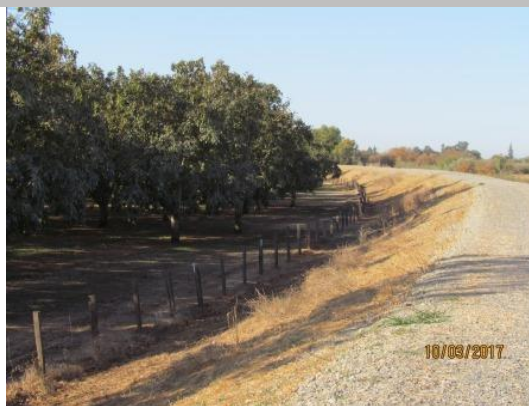
Photo 1 of 2 : SP_2018_RD0817_12_8_20180302_00001.jpg

LM Start	1.74	Rating **	M	Issue No.	8
LM End	3.81	Issue Type +	En	Location *	LS
Category	Earthen Levee			GPS Latitude/Longitude	
				Start	End
Item	Encroachments			39.002941 °	39.019763 °
				-121.484856 °	-121.454151 °
DWR ID	DWR_RD0817_01_s_2013_8				
Comment Code					
FE : Fence					
Inspector Comment					
Wire fence at L/S levee toe.

Wire fence still exist at the landside levee toe. Fall 2017.

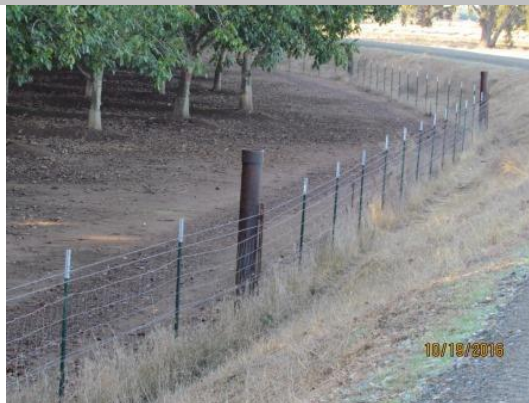
Photo 2 of 2 : SP_2018_RD0817_12_8_20180302_00002.jpg

Wire fence at L/S levee toe. Fall 2016.

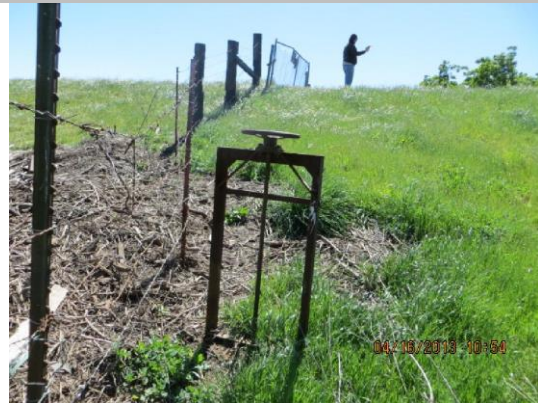
Photo 1 of 1 : UCIP_SP_2018_41156_19895.jpg

Comment Code					
Inspector Comment					
FS_ID:41156 DS_ID:18989 EP_NO: N/A Repair Type: Non-Urgent Crossing Status: Indicator Found UCIP Comments: A burried slide gate found on WS. Need to contact owner to determine status of crossing. If crossing is no longer in use owner will need to contact CVFPB to comply with Title 23. Dense vegetation on waterward and landward slopes limit visual inspection of potential leaks along pipe alignment. Recommend having owner clear vegetation along slopes. FIELD_STRUCT_DESC: *ABANDONED* 18-inch corrugated metal gravity drainage pipe through levee, 11.7 feet below the crown. Slide gate on the waterside (WS) end. (Removal of 18-inch pipe and appurtenances authorized under Permit No. 16193, 1994 - Reclamation District No. 817. Slide gate still remains on the WS toe). [Additional Reference(s): DWR Levee Log, 2005. USACE Sacramento O&M Manual 146, November 1962, (HLM 2.29)]. FS Date: 4/16/2013

WS- slide gate on levee toe.

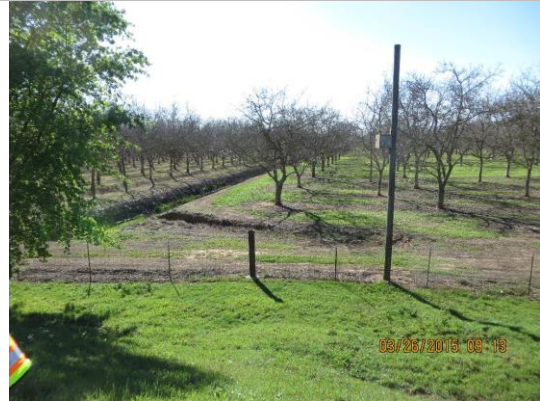
Photo 3 of 3 : UCIP_SP_2018_43946_73420.jpg

LS of pipe buried but alignment would place LS outlet just left of telephone pole on LS toe.

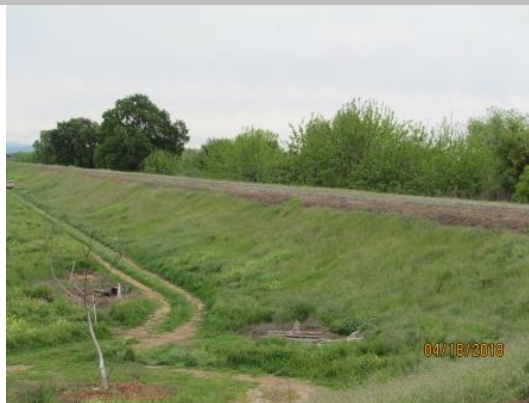
Photo 1 of 1 : SP_2018_RD0817_13_10_20180501_00026.jpg

View looking upstream landside of the maintained annual vegetation, Spring 2018.

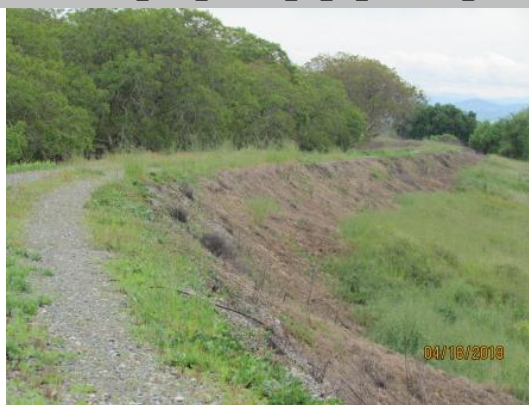
Photo 1 of 1 : SP_2018_RD0817_13_16_20180501_00028.jpg

View looking upstream waterside of the maintained annual vegetation, Spring 2018.

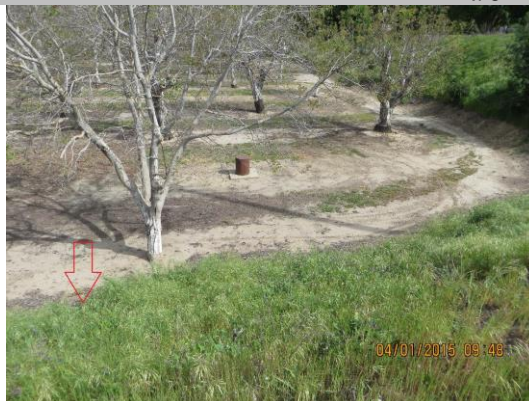
Photo 1 of 3 : UCIP_SP_2018_44064_73542.jpg

Concrete standpipe visible on lower slope of LS toe.

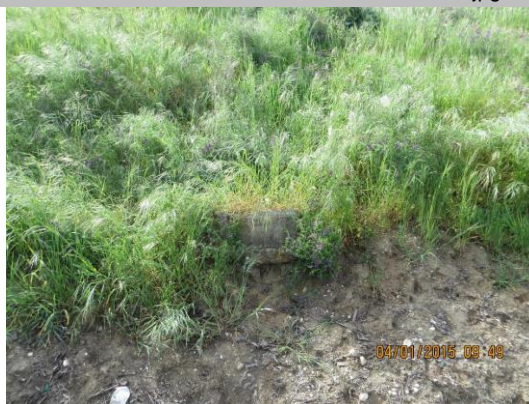
Photo 2 of 3 : UCIP_SP_2018_44064_73541.jpg

Concrete standpipe visible on lower slope of LS toe.

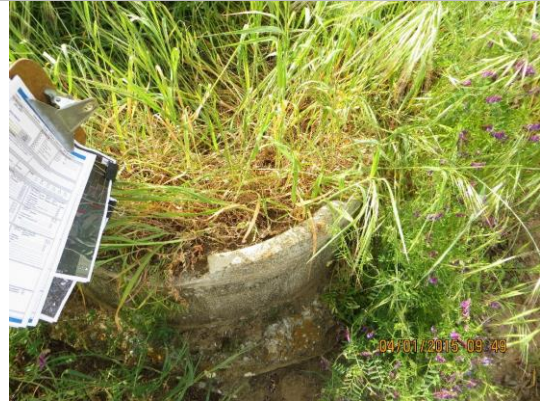
Photo 3 of 3 : UCIP_SP_2018_44064_73540.jpg

Concrete standpipe visible on lower slope of LS toe.

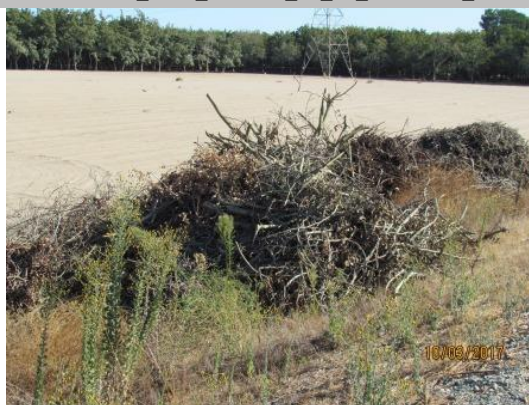
Photo 1 of 1 : SP_2018_RD0817_13_11_20180302_00003.jpg

View of pruning's on the landside levee toe, Fall 2017.

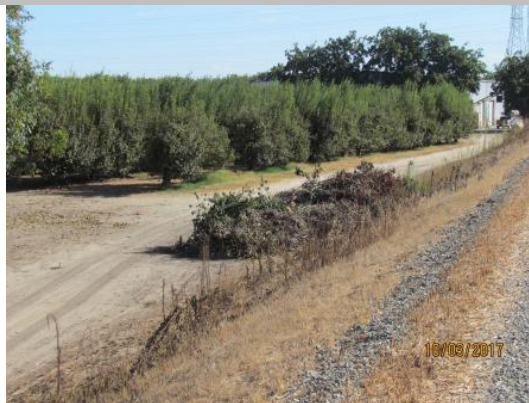
Photo 1 of 1 : SP_2018_RD0817_13_22_20180302_00013.jpg

View looking upstream landside of pruning's on the levee toe, Fall 2017.

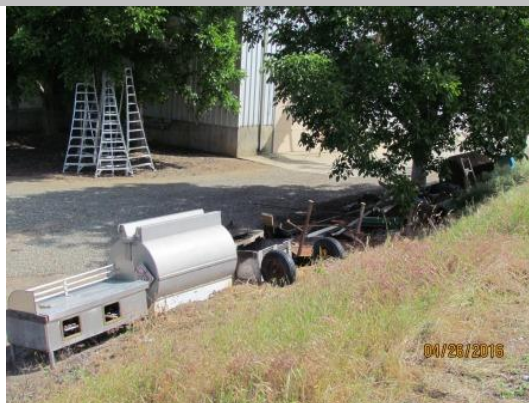
Photo 1 of 1 : SP_2018_RD0817_13_3_20180302_00002.jpg

Photo of equipment encroaching onto the landside toe. This is still the same for Fall 2016 inspection.

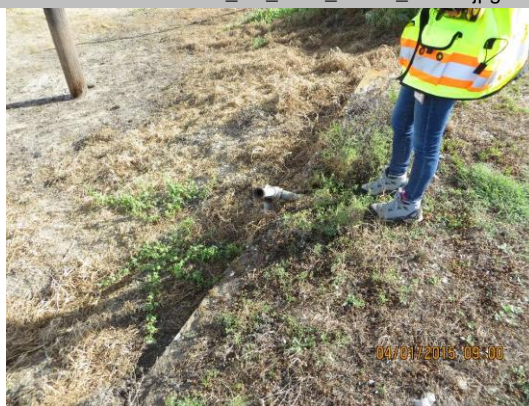
Photo 1 of 3 : UCIP_SP_2018_44105_73586.jpg

Pipe visible on LS shoulder.

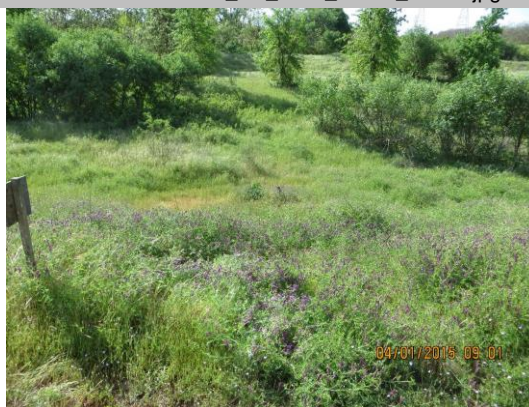
Photo 2 of 3 : UCIP_SP_2018_44105_73585.jpg

WS slope. pipe not visible.

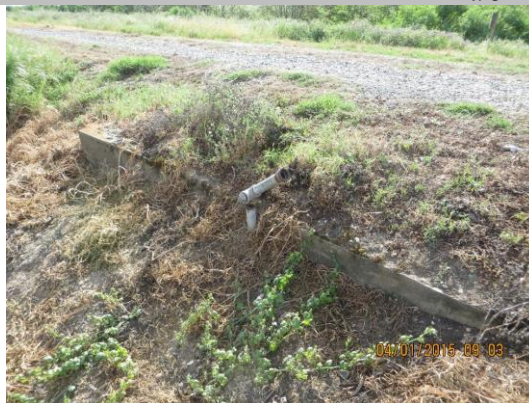
Photo 3 of 3 : UCIP_SP_2018_44105_73584.jpg

Pipe and concrete headwall visible on LS shoulder.

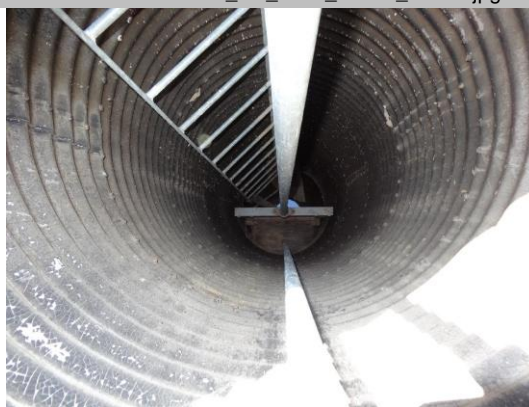
Photo 2 of 3 : UCIP_SP_2018_41160_19921.jpg

WS- inside CMP riser with air vent and slide gate.

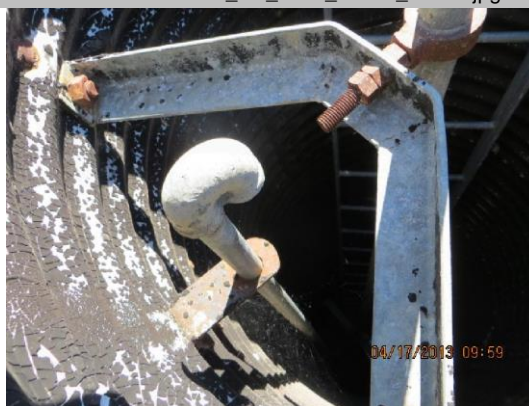
Photo 3 of 3 : UCIP_SP_2018_41160_19920.jpg

WS- CMP riser with air vent and slide gate.

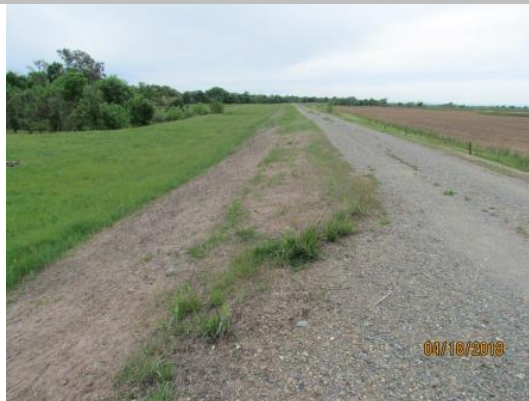
Photo 1 of 1 : SP_2018_RD0817_14_13_20180501_00029.jpg

View looking downstream waterside of the maintained annual vegetation, Spring 2018.

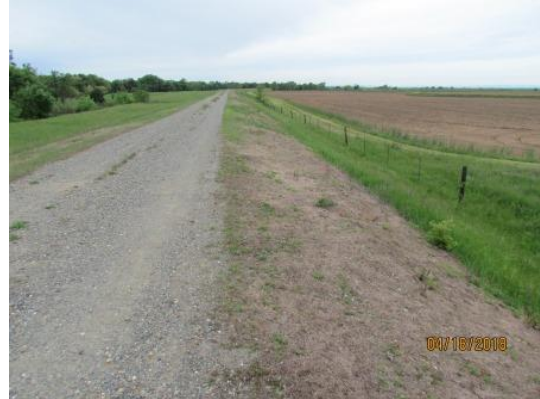
Photo 1 of 1 : SP_2018_RD0817_14_12_20180501_00030.jpg

View looking downstream landside of the maintained annual vegetation, Spring 2018.

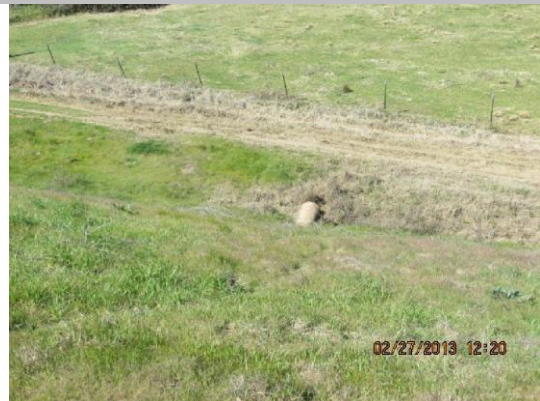
Photo 1 of 3 : UCIP_SP_2018_50231_54271.jpg

Pipe at LS toe

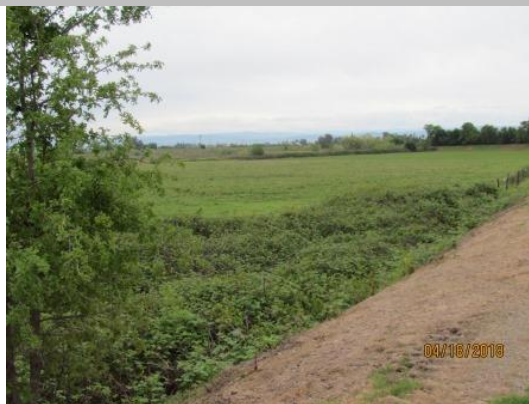
Photo 1 of 1 : SP_2018_RD0817_14_8_20180501_00031.jpg

View of blackberry bushes that are taking over the landside slope looking upstream. Spring 2018.

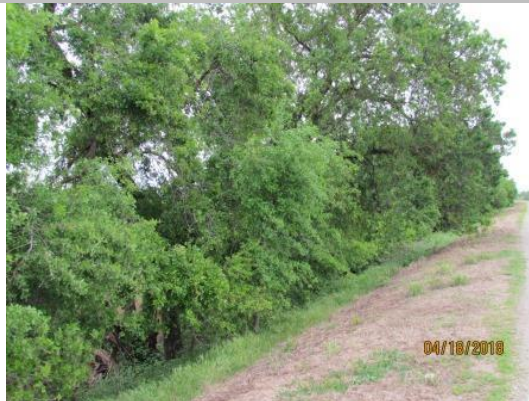
Photo 1 of 2 : SP_2018_RD0817_14_4_20180501_00032.jpg

View looking downstream of trees that need limbs to be trimmed for access and visibility, Spring 2018.

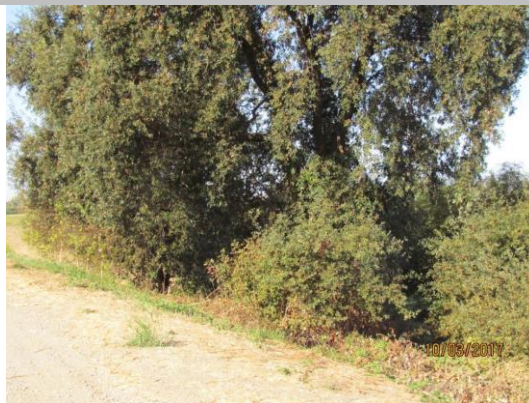
Photo 2 of 2 : SP_2018_RD0817_14_4_20180302_00001.jpg

View looking downstream of trees that need limbs to be trimmed for access and visibility, Fall 2017.

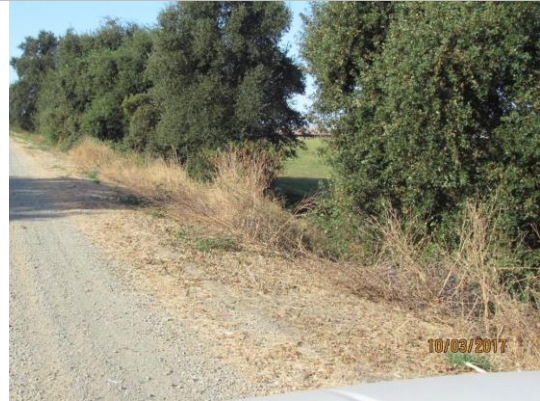
Photo 1 of 1 : SP_2018_RD0817_14_18_20180302_00005.jpg

View looking downstream of Black Berry bushes, trees and other wild growth that are taking over the landside slope this remains the same for Fall 2017.

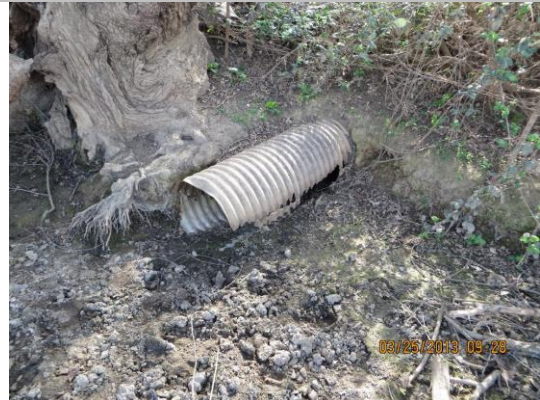
Photo 1 of 3 : UCIP_SP_2018_50230_53849.jpg

Pipe on LS toe corroded through.

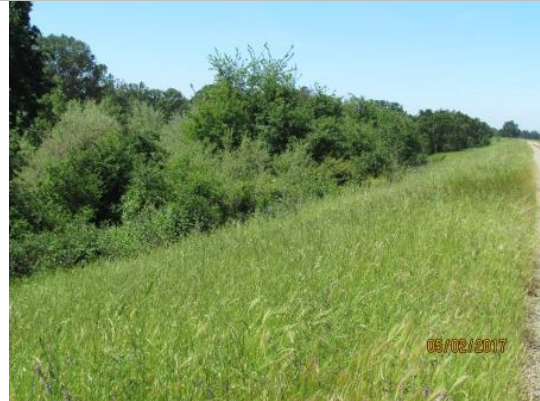
Photo 1 of 1 : SP_2018_RD0817_14_20_20180302_00007.jpg

View looking downstream of trees and bushes that block the view of the levee slope, Spring 2017 and remain the same for Fall 2017.

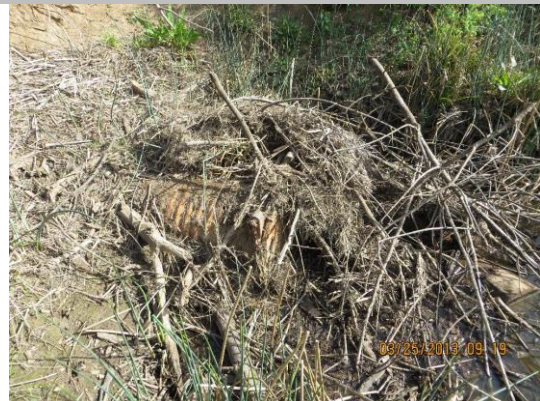
Photo 1 of 3 : UCIP_SP_2018_50232_53854.jpg

Pipe and flapgate at WS toe blocked by debris.

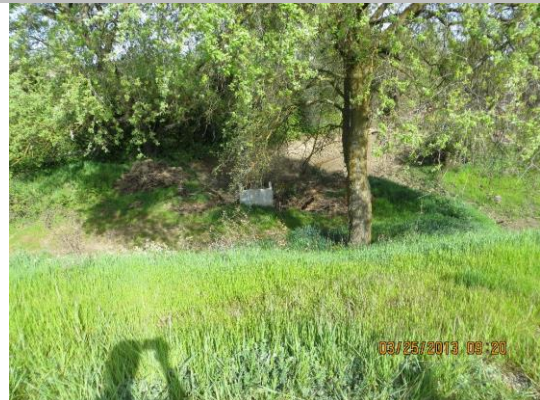
Photo 3 of 3 : UCIP_SP_2018_50232_53852.jpg

Improvised concrete inlet on LS toe.

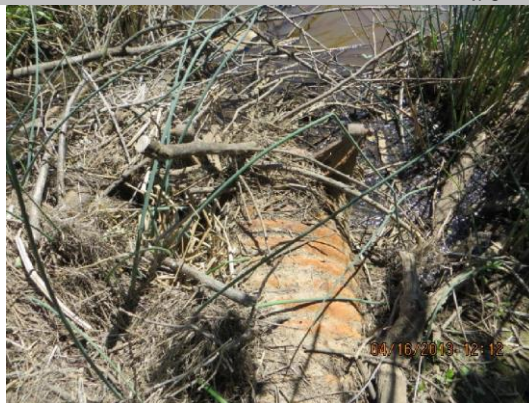
Photo 1 of 3 : UCIP_SP_2018_41163_19942.jpg

WS- CM pipe, flap gate and debris.

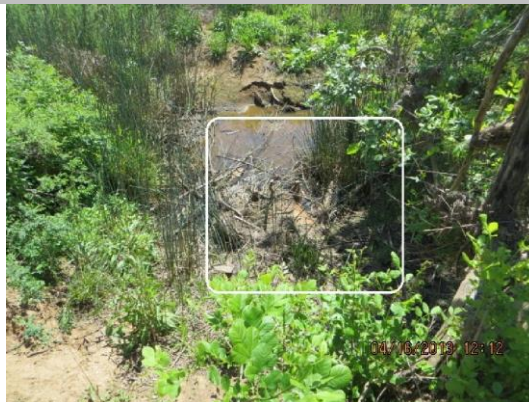
Photo 2 of 3 : UCIP_SP_2018_41163_19941.jpg

WS- overview of CM pipe, flap gate and debris.

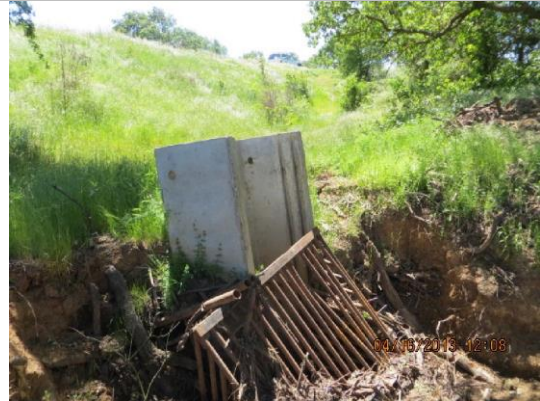
Photo 3 of 3 : UCIP_SP_2018_41163_19940.jpg

LS- half box concrete outlet structure with trash rack.

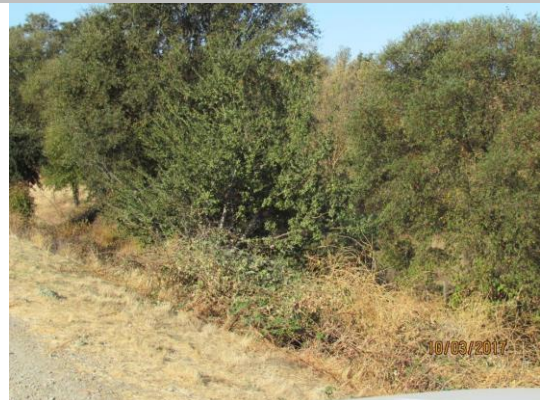
Photo 1 of 1 : SP_2018_RD0817_14_19_20180302_00006.jpg

View looking downstream landside of trees that need limbs to be trimmed for access and visibility, Fall 2017.

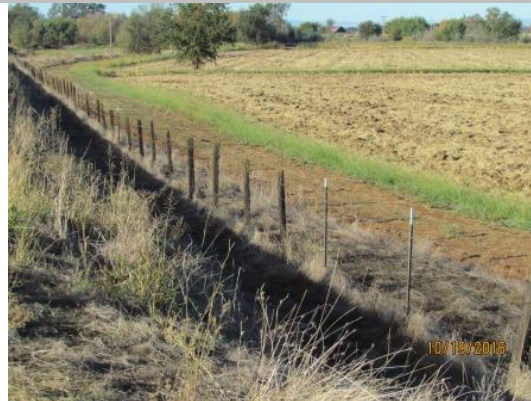
Photo 1 of 1 : SP_2018_RD0817_14_15_20180302_00004.jpg

View of fence at landside toe looking downstream.

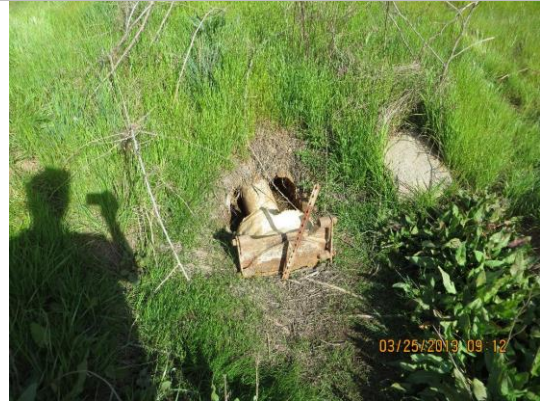
Photo 2 of 3 : UCIP_SP_2018_50234_53856.jpg

Pipe cut behind flap gate on WS toe with 8-inch PVC.

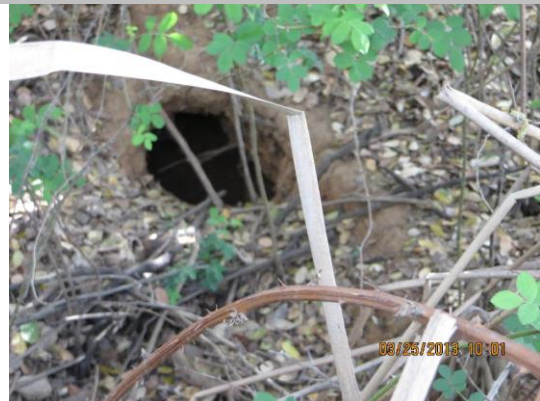
Photo 2 of 3 : UCIP_SP_2018_50235_53858.jpg

Sinkhole or animal burrow over pipe on LS toe.

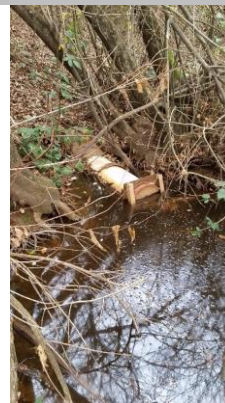
Photo 3 of 3 : UCIP_SP_2018_50235_74804.jpg

WS drainage outlet with flap gate. Steel pipe is sleeved within heavily rusted CM pipe near daylight to embankment
